# Manhole Inspection Summary

Manhole # S41E2\_005MH

**Inspection** ☐ Is Incomplete Rating: **2) Good**

**Location** Address: **829 6th St**

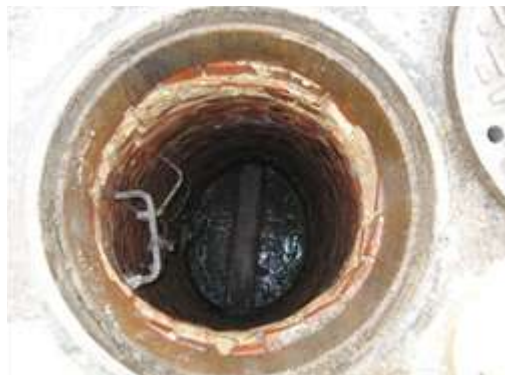
Top View

**Steps** Count: **7** Missing: **0** ☒ **Corroded**

steps

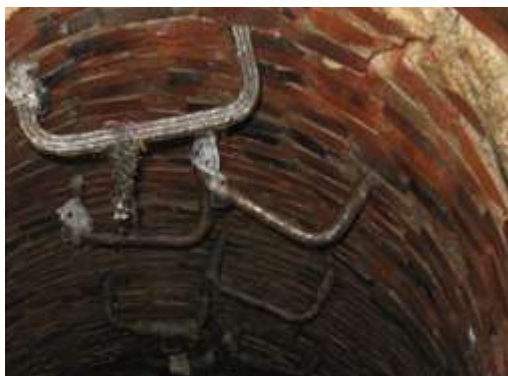
Defect 2

debris

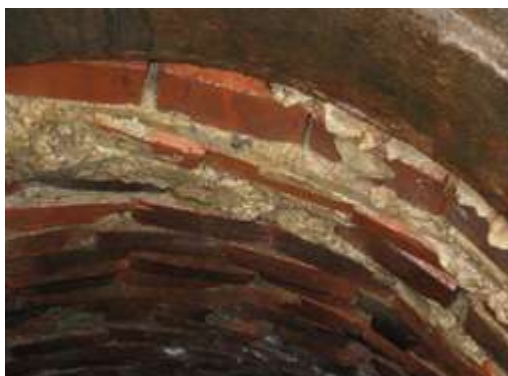
Defect 1

Condition: ☐ Sound ☐ Cracked ☐ Root Intrusion ☒ **Loose Brick** ☐ Deteriorated

Infiltration: ☐ None ☐ Joint ☐ Cracks ☒ **Mortar** ☐ Roots ☐ Wall

loose bricks and mortar on chimney

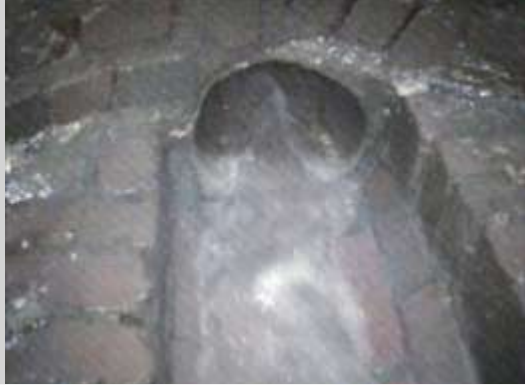
12 O'Clock Outflow

Pipe Height: **9.6** (in.) Rod and Bar (Angled)  
Pipe Material: **Clay** ☐ Pipe Lined  
Invert Depth: **13.72** (ft.) Flow Characteristics: **Fast**  
Deposits: ☒ None ☐ Mud ☐ Sludge ☐ Debris ☐ Grease  
Silt Depth: (in.) Deposits Extent:  
Infiltration: **None** Pipe Seal Cond: **Sound**

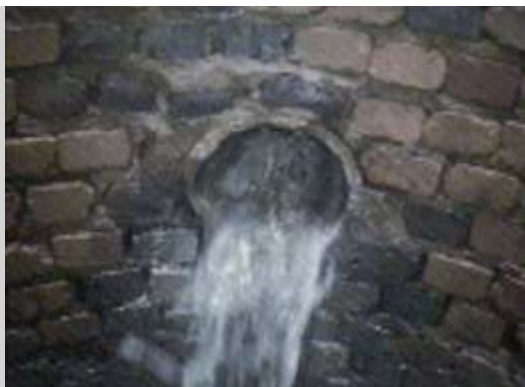
6 O'Clock Inflow

Pipe Height: **9.6** (in.) Rod and Bar (Angled)  
Pipe Material: **Clay** ☐ Pipe Lined  
Invert Depth: **11.61** (ft.) Flow Characteristics: **Fast**  
Deposits: ☒ None ☐ Mud ☐ Sludge ☐ Debris ☐ Grease  
Silt Depth: (in.) Deposits Extent:  
Infiltration: **None** Pipe Seal Cond: **Sound**

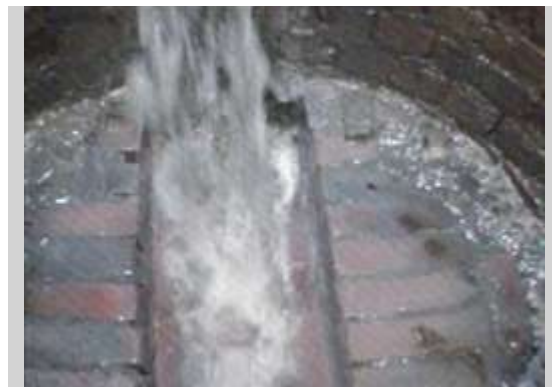
Drop In @ 6 O'Clock

Drop: **Outside** Rod and Bar  
Angled: **Yes** Reading: **12.32** (ft.)  
Inv Depth: **13.32** (ft.)  
Drop Condition: **Open**
